**Display**

Subject: **NO OUTPUT OF BUILT-IN SIGNALS**

Model: **BVM-14E1U, BVM-14E5U, BVM-14F1U  
BVM-14F5U, BVM-14G1A, BVM-14G1E  
BVM-14G1U, BVM-14G5A, BVM-14G5E  
BVM-14G5U, BVM-20E1U, BVM-20F1U  
BVM-20G1A, BVM-20G1E, BVM-20G1U**

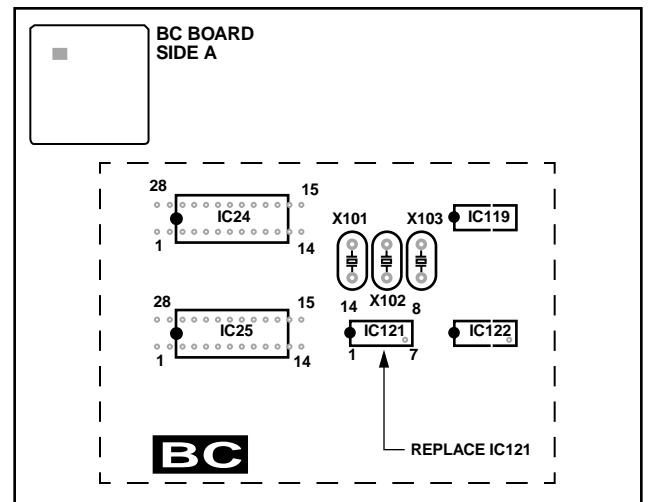
**Figure 1**

When executing automatic white balance, an error may appear as the 100% white signal is not output. Also, the built-in signals (CH91 to CH99) are not output.

**BC Board, Side A  
(See Figure 1.)**

1. Replace IC121 (TC74VHCU04) with the new IC MC74HCU04AF.
