Broadcast Products Technical Bulletin 20-2004-140

SUBJECT: RASTER EXPANDS/CONTRACTS IN
HORIZONTAL DIRECTION

MODEL: ***BVM-D9H1A***
BVM-D9H1E
BVM-D9H1U
BVM-D9H5A
BVM-D9H5E
BVM-D9H5U

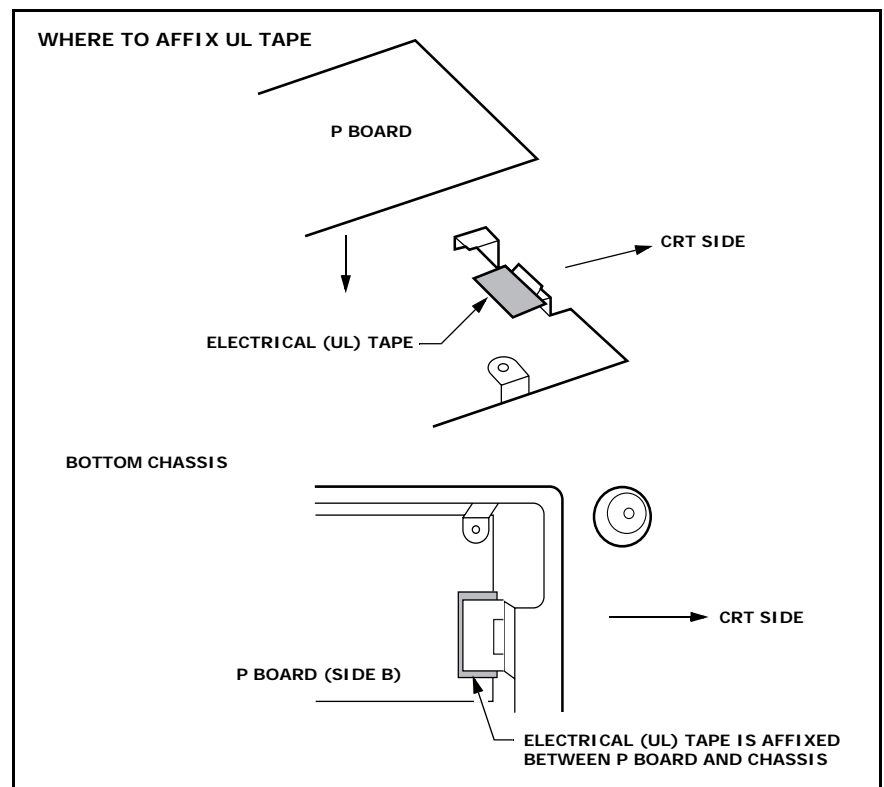
Figure 1

Raster may expand and/or contract in a horizontal direction. This symptom occurs due to accidental contact between a thru-hole on the P board and the bottom chassis.

NOTE: The P board is mounted beneath the CRT.
2. Affix electrical (UL) tape to the bottom chassis as shown in Figure 1.

NOTE: Fold the over-lapping edge of the tape around to the rear side of the bottom chassis.
3. Reinstall the P board and the top cover.
